## CASE REPORT

# Management of Internal Resorption with Perforation

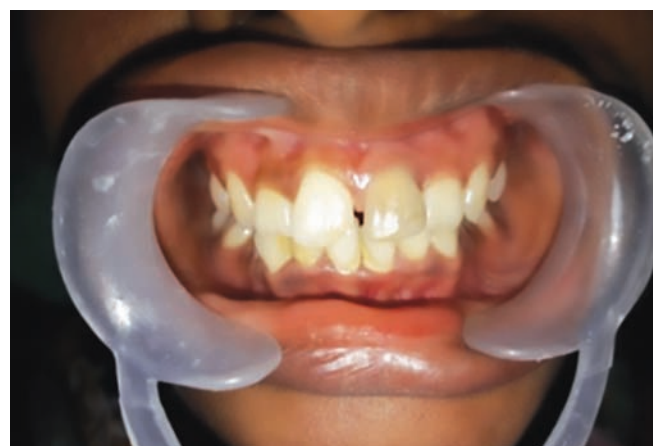
**Fig. 1:** Preoperative image showing brownish discoloration with composite restoration on distal aspect of 21

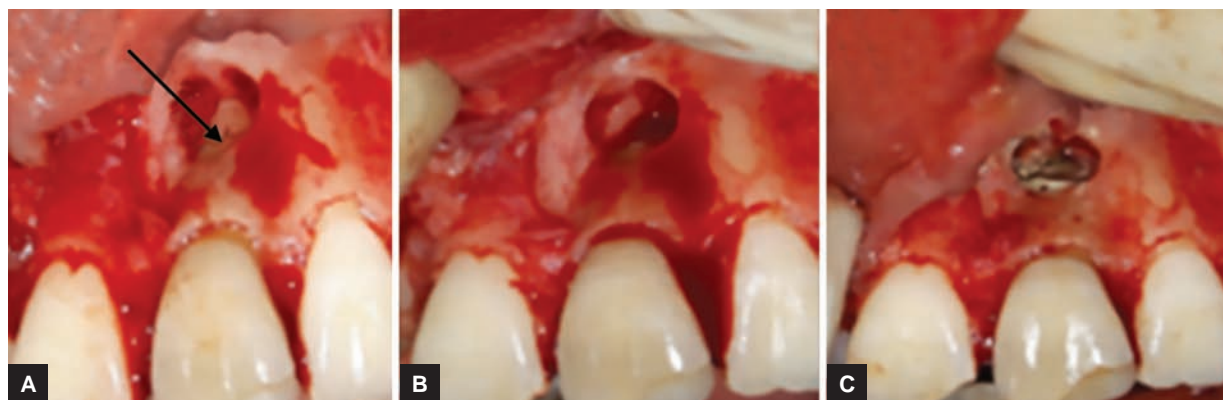
**Figs 3A to C:** (A) Overextended gutta-percha in apical third of root of 21 (shown by black arrow). (B) Root end resection done up to the perforation site in 21. (C) Retrograde preparation followed by retrograde filling done with MTA in 21

An informed consent from the patient was taken. The root canal retreatment was initiated under rubber dam isolation in 21. The access cavity was redefined using Endo Access Bur and gutta-percha was retrieved. Bleeding from canal was present. Calcium hydroxide dressing was given for initial two appointments at an interval of 10 days. The root canal of 21 was then obturated using customized gutta-percha and Endoseal MTA sealer (ENDOCEM, Maruchi Products). After completion of root canal treatment, the surgical procedure ensued. A full-thickness mucoperiosteal triangular flap was elevated extending from mesial of 23 to distal of 12. The overextended gutta-percha through the perforation site at the apical third of root of 21 was identified and removed (Fig. 3A). Curettage was done followed by root end resection up to the perforation site (Fig. 3B), retrograde preparation, and retrograde filling with MTA (Angelus Solucoes Odontologicas, Londrina, PR, Brazil) (Figs 3C and 4). The flap was repositioned and sutured back. After 3 months, a metal ceramic crown was

In case report 1, the location of perforation was in the apical area of the root, and repair was planned surgically after obturation of canal space. Endoseal MTA was used as a sealer along with customized gutta-percha for obturation. The novel sealer Endoseal MTA is based on MTA and had comparable sealing ability to a proprietary brand sealer cement. In contact with a simulated body fluid, the MTA sealer released calcium ions in solution that encouraged the deposition of calcium phosphate crystals.<sup>8</sup> It is available in paste-type, premixed, and preloaded in a syringe that allows direct application of the sealer into the root canal without requiring powder/liquid mixing. Since perforation was in nonesthetic area, MTA was used as repair material, which results in new cementum formation and periodontal regeneration, despite its extrusion into periradicular tissues.<sup>9</sup> Set MTA can acquire its optimal strength and produce excellent sealability in the inherently wet environment of the perforation.<sup>9</sup>

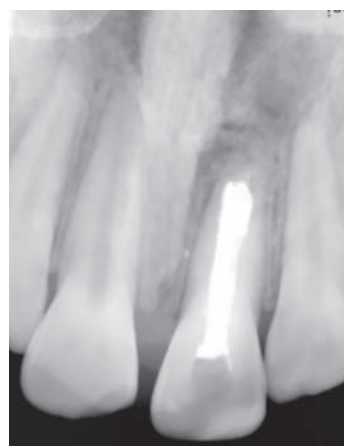
**Fig. 4:** Immediate postoperative radiograph of 21

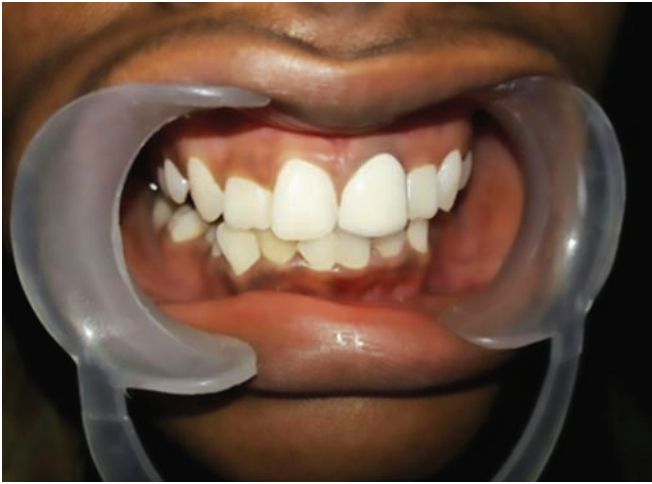
Fig. 5: Restoration of 21 with metal–ceramic crown

given as postendodontic restoration (Fig. 5). At the end of 1 year, the patient was completely asymptomatic with radiographic evidence of healing (Fig. 6).

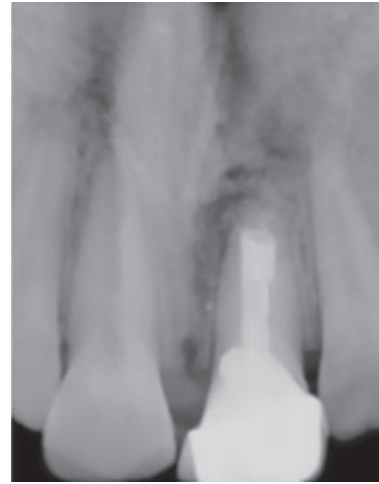
Fig. 6: Follow-up radiograph at the end of 1 year

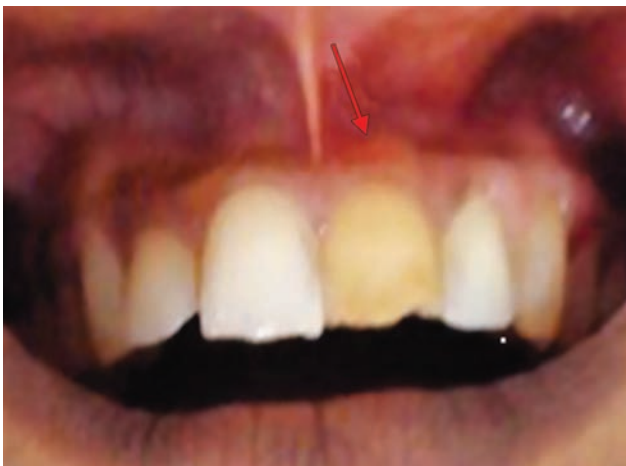
Fig. 7: Preoperative image showing discolored 21 with redness of the alveolar mucosa and a draining sinus tract (shown by red arrow)

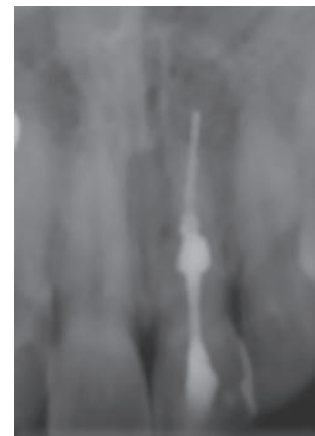
Fig. 8: Preoperative radiograph showing presence of radiopacity in the root canal of 21 extending beyond the radiographic apex with characteristic hour glass-shaped radiopacity in the middle third of the root of 21

A 40-year-old female patient reported to the department with the chief complaint of dull aching pain since 3 weeks and discoloration of upper front tooth. Patient had a history of trauma 4 years ago followed by a gradual change in color of tooth. Patient had undergone root canal treatment in a private dental clinic a week ago. Intraoral examination revealed previously root canal treated and discolored 21 with redness of the alveolar mucosa and a draining sinus tract in relation to 21 (Fig. 7). On probing, the periodontal probing depth on the labial aspect of 21 was 7 mm with extrusion of gutta-percha through the gingival sulcus. Radiographic investigation revealed the presence of radiopacity in the root canal of 21 extending beyond the radiographic apex. There was a characteristic hour glass-shaped radiopacity in the middle third of the root of 21 (Fig. 8).

Correlating the clinical and radiographic findings, the case was provisionally diagnosed as previously treated 21 with perforating internal inflammatory resorption and symptomatic apical periodontitis.

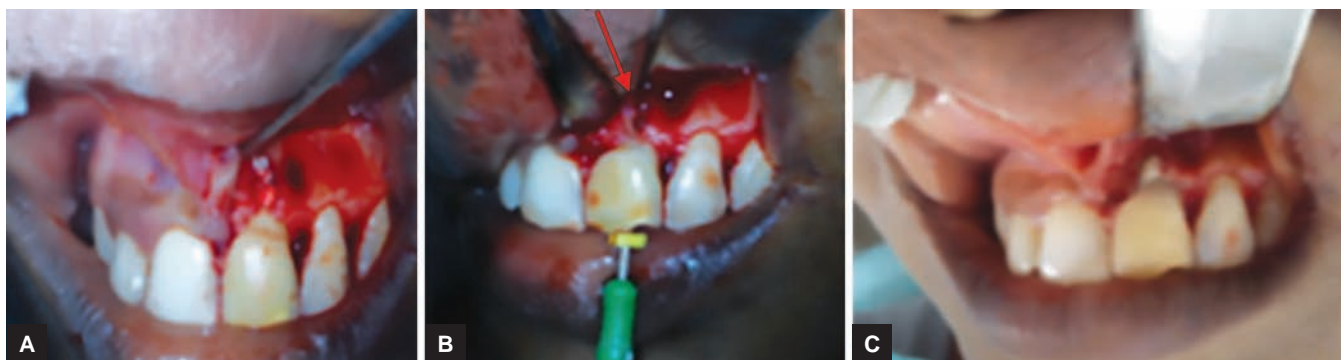
**Figs 9A to C:** (A and B) Identification of perforation site at the middle third of 21 root (shown by red arrow). (C) Repair of perforation site of 21 with biodentine (Septodont)

Under rubber dam isolation, access was regained in 21 and gutta-percha was retrieved. The canal was irrigated with 3% sodium hypochlorite, and intracanal Ca(OH)<sub>2</sub> dressing was placed to arrest the inflammatory process and induce repair. Full-thickness mucoperiosteal flap was raised in relation to 21, and perforation site identified in the middle third of root measuring 2 mm in diameter (Figs 9A and B). The granulation tissue was curetted from perforation site, and apical third of the canal was obturated with master cone of 60 size 2% gutta-percha. Followed by this, the perforation site was repaired using Biodentine (Septodont) (Fig. 9C) and the flap was sutured back in position. Remaining canal was obturated with thermoplasticized gutta-percha (Fig. 10); 21 was restored with indirect composite veneer (Fig. 11) after 1 month. After a follow-up period of 24 months, 21 was asymptomatic clinically and radiographically.

In case report 2, repair of defect at cervical third of the root was done surgically before obturation of canal. Since defect was more towards esthetic area, Biodentine

was preferred to be used as repair material. It is known as dentin in a capsule, a biocompatible and bioactive dentin substitute, which overcomes the drawbacks of calcium hydroxide and MTA. Biodentine holds promise for clinical dental procedures as a biocompatible and easily handled product with less cost and short setting time. Thermoplasticized gutta-percha was used to fill the reminiscent portion of the canal due to the passivity of the technique.

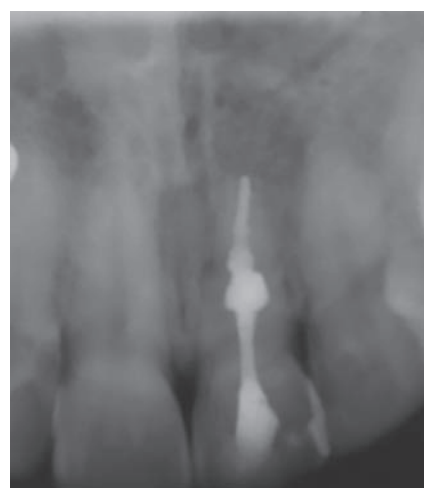
**Fig. 10:** Immediate postoperative radiograph

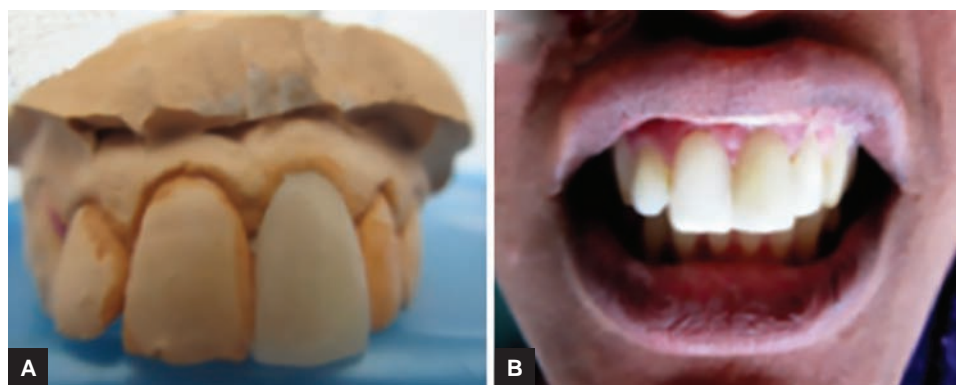
**Figs 11A and B:** (A) Indirect composite veneer fabricated on 21. (B) Clinical photograph showing 21 restored with indirect composite veneer
